Re-Use Guidelines

Hangar 3 (Building No. 47) NASA Ames Research Center Moffett Field, California

August 30, 2006

Prepared by
PAGE & TURNBULL, INC.
San Francisco, California

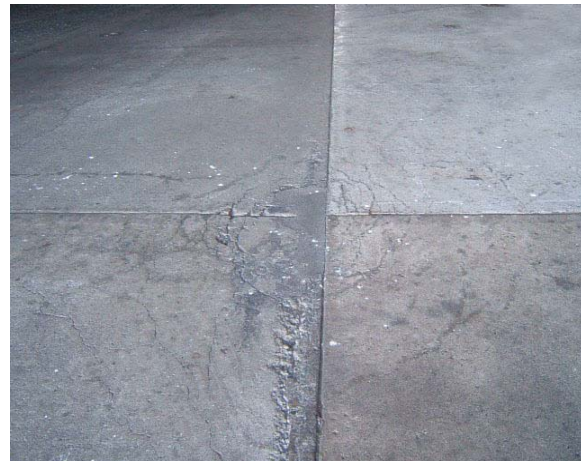
Minor cracking is evident throughout the slab, particularly at the corners of the floor panels where the slab is weakest (**Figure 42**). These cracks are typical for large concrete pours and do not appear to affect the structural performance of the foundation. The slab appears to be intact with no major swells or dips.

Figure 42 Concrete floor slab (typical), Hangar 2 south entry (Hangar 3 similar).

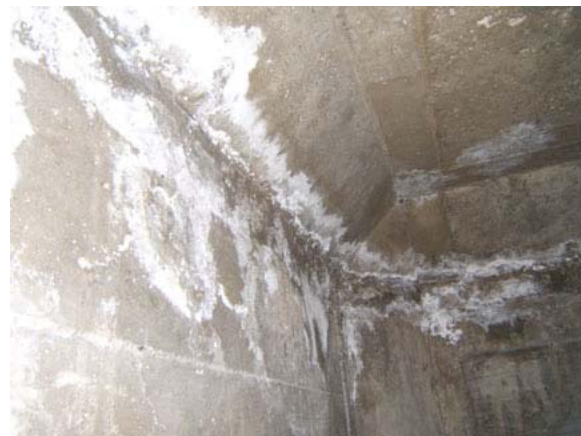
Efflorescence, a deposit of soluble salts and minerals, was noted on the interior of the towers, indicating water transmission through the masonry (**Figure 43**). During the process of water transmittal, salts are hydrated and subsequently moved to the surface. This appears as a white powder and often follows the flow of existing structural cracks. Though this is typically not a problem itself, efflorescence is an indicator of water infiltration that can also cause the corrosion and expansion of embedded steel reinforcement.

Figure 43 Efflorescence on the interior of the door tower, Hangar 2 southeast tower (Hangar 3 similar).

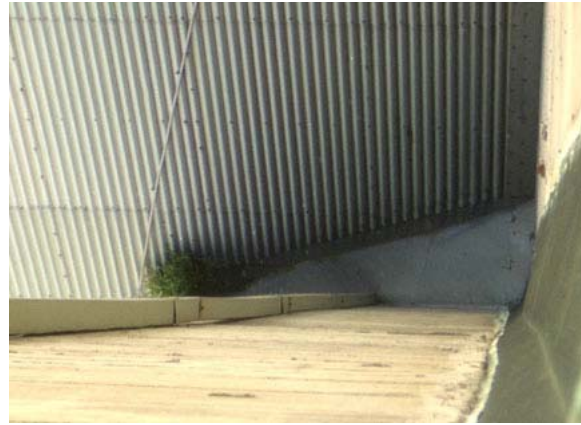
Figure 44 Organic growth found at junction between roof slope and hangar door, Hangar 2 southwest tower (Hangar 3 similar).

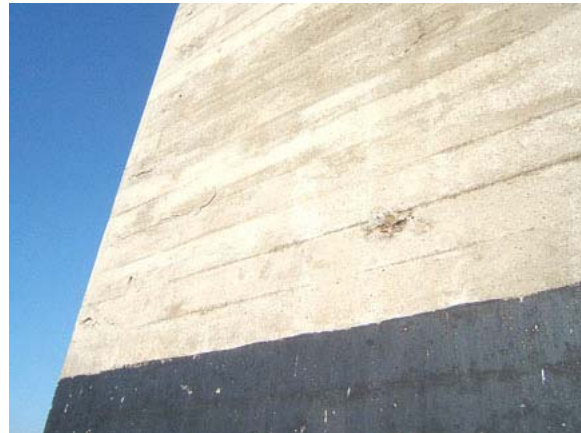
Figure 45. Concrete spall on northwest corner tower, Hangar 2 (Hangar 3 similar).

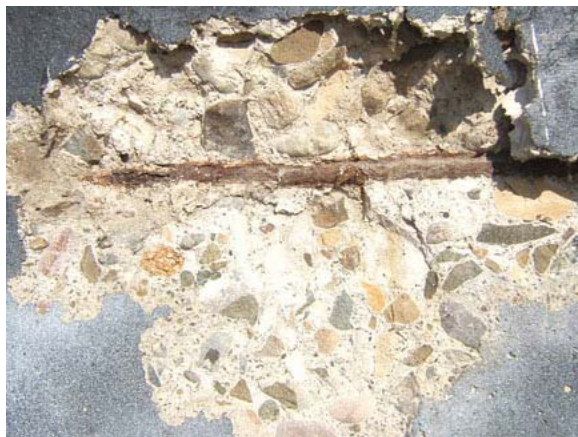
Figure 46. Detail of concrete spall, northwest door tower, Hangar 2 (Hangar 3 similar).

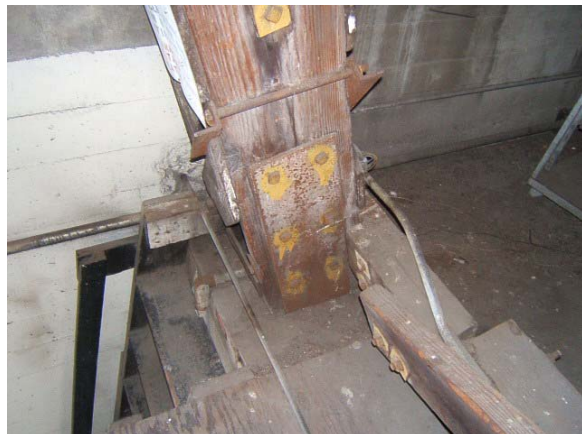
Figure 47: Interface between wood truss and concrete bent, Bent #1, west junction.

Mechanical testing of the fasteners was not possible for this report and should be considered during the reuse of the Hangars. Upon a visual inspection on February 2, 2006 with 16x23 binoculars, all bolts and fasteners appeared to be intact. There is rusting and salt damage on the connection plates between the wooden truss members and concrete bents (**Figure 47**). The number of bolts connecting the wood trusses together and the trusses to the concrete bents should be assessed by a structural engineer. The

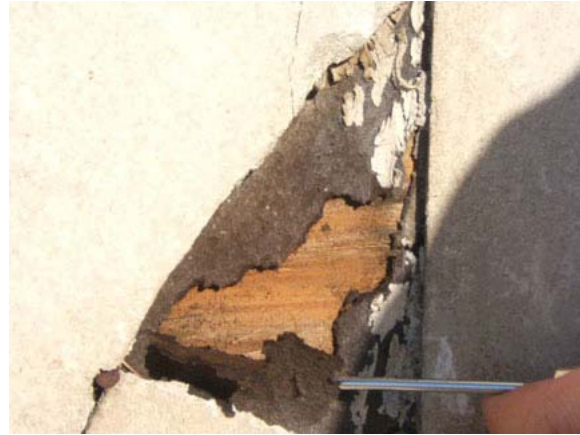
The exterior and interior walls of the office infill spaces, the monumental doors, and the door girder are all clad in cement asbestos panels. This composite material is lightweight and was popular in high heat areas, such as chimneys, boiler rooms, and structures that required high fire resistance, like Hangar 2. The 4 foot by 8' foot panels are nailed or screwed to a substrate of lath board or plywood. As the panels age, the cement component continues to harden, rendering the panels brittle. In a few locations, they have broken, exposing the tarpaper and wood substrate (Figure 48).

Figure 48. Deteriorated cement asbestos panel showing underlayment of tarpaper and wood substrate, northern corner of the west facade, Hangar 2 (Hangar 3 similar).

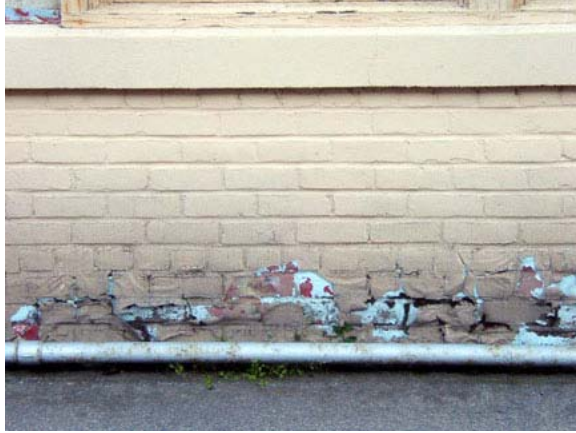
Painting has accelerated the deterioration of the brick by interfering with the moisture transmission process (**Figure 49**). Brick, a porous semi-permeable material, uses evaporation to move water through itself and a layer of paint prevents the natural evaporation of this moisture. Water can infiltrate the brick through many sources, but at the stem wall, the primary source is rising damp, when ground water enters the foundation through capillary action. The “water-table,” or the point at which the moisture moves to the surface and evaporates, is evidenced by a line of salts and organic material on the surface of the brick wall. This line suggests that rising damp is infiltrating the stem wall and a number of problems are pending. First, water is likely collecting under the structure. Second, as the water moves through the masonry, salts in the brick and mortar are hydrated. This continual expansion of the salts will eventually lead to the destruction of the bricks as a result of sub-florescence.

Figure 49. Water table, line of rising damp evaporation causing paint to fail, west façade Hangar 3.
